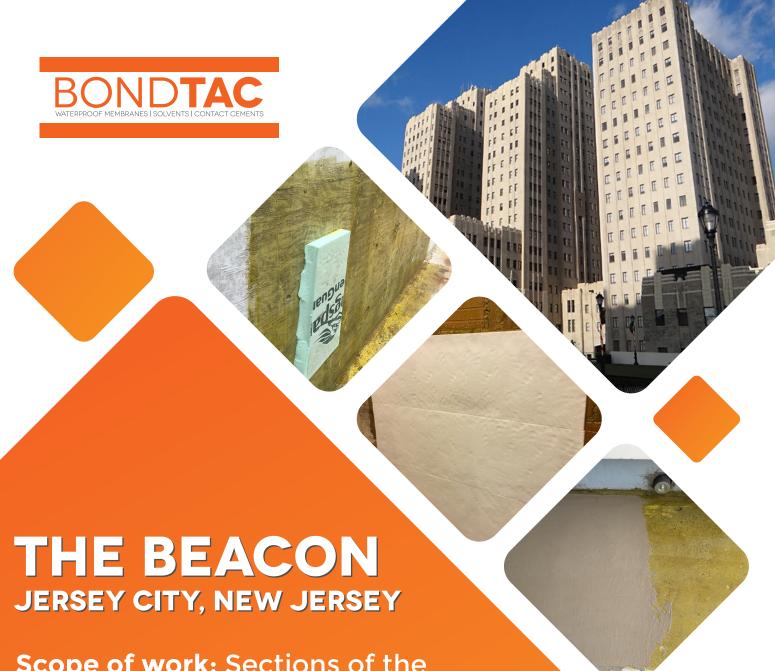
Scope of work: Sections of the complex's underground network of storage rooms, hallways, and a main electrical room had been experiencing water infiltration. The waterproofing company that was contracted prepped the surfaces by cleaning them and using commercial dehumidifiers to dry the surfaces. They applied BondTAC 1500 to these affected areas and then painted over the protected surfaces.
